WDNR Professionally Assured Wetland Delineation Report

Lake Forest Condominiums

Town of Washington

Vilas County, Wisconsin

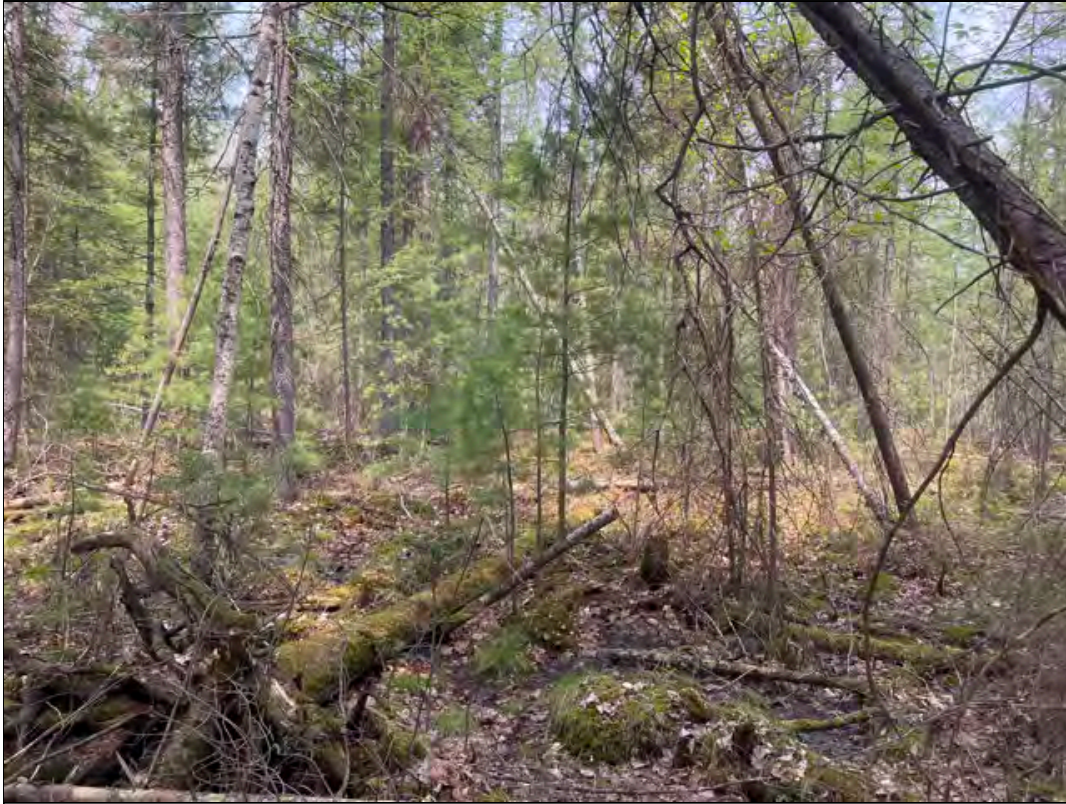
WET 1-1

Plot Wet 1-1: The plant community met wetland vegetation criteria with the Dominance Test (80.0%) and the Prevalence Index (1.989) being met. The dominant vegetation at the sample plot included red maple, black spruce, eastern white pine and sphagnum moss. Saturation and high water table were observed at the soil surface. Primary wetland hydrology indicators A2 (High Water Table), A3 (Saturation), B9 (Water-Stained Leaves) and secondary indicators D2 (Geomorphic Position) and D5 (FAC-neutral Test) were present. NRCS hydric soil indicator A1 (Histosol) was present.

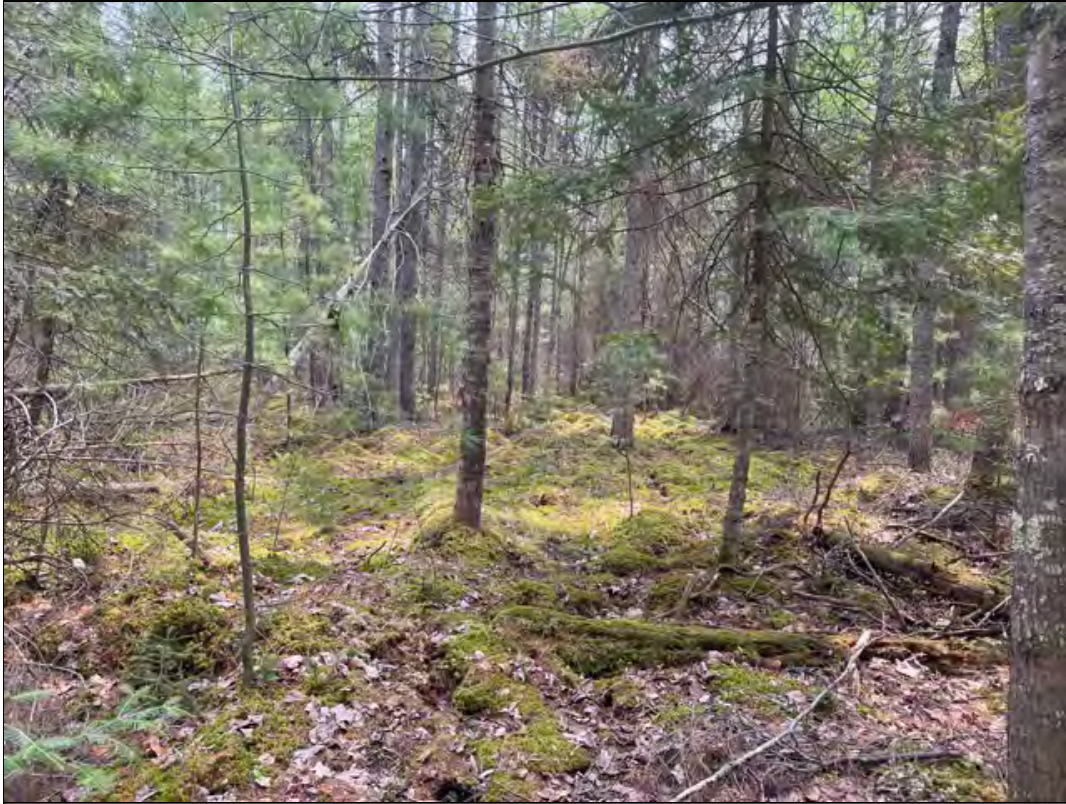
WET 1-2

Plot Wet 1-2: The plant community met wetland vegetation criteria with the Dominance Test (75.0%) and the Prevalence Index (1.698) being met. The dominant vegetation at the sample plot included tamarack, black spruce, eastern white pine and sphagnum moss. Saturation was observed at the soil surface and high water table at -1 inch below the soil surface. Primary wetland hydrology indicators A2, A3 and secondary indicators D2 and D5 were present. NRCS hydric soil indicator A2 (Histic Epipedon) was present.

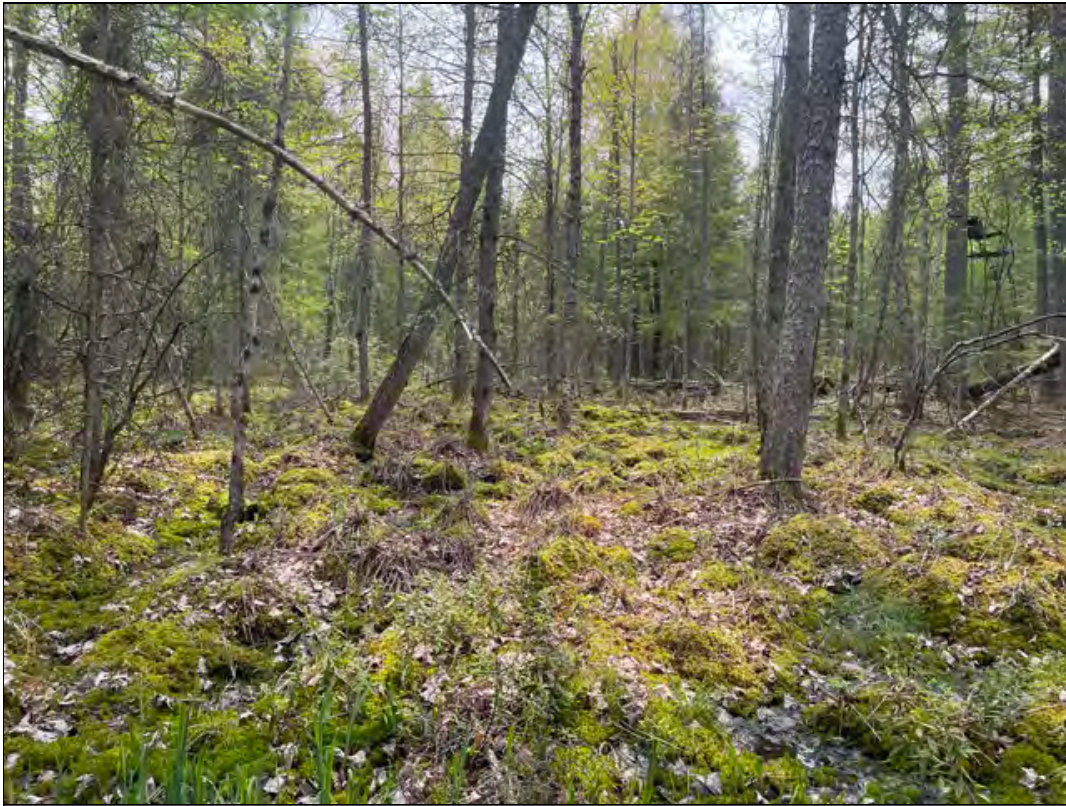
WET 2-1

Plot Wet 2-1: The plant community met wetland vegetation criteria with the Dominance Test (87.5%) and the Prevalence Index (1.648) being met. The dominant vegetation at the sample plot included tamarack, red maple, black spruce, eastern white pine, balsam fir, sphagnum moss and cinnamon fern. Surface water was observed at +1 inch above the soil surface. Primary wetland hydrology indicators A1 (Surface Water), A2, A3, B9 and secondary indicators D2 and D5 were present. NRCS hydric soil indicator A1 was present.

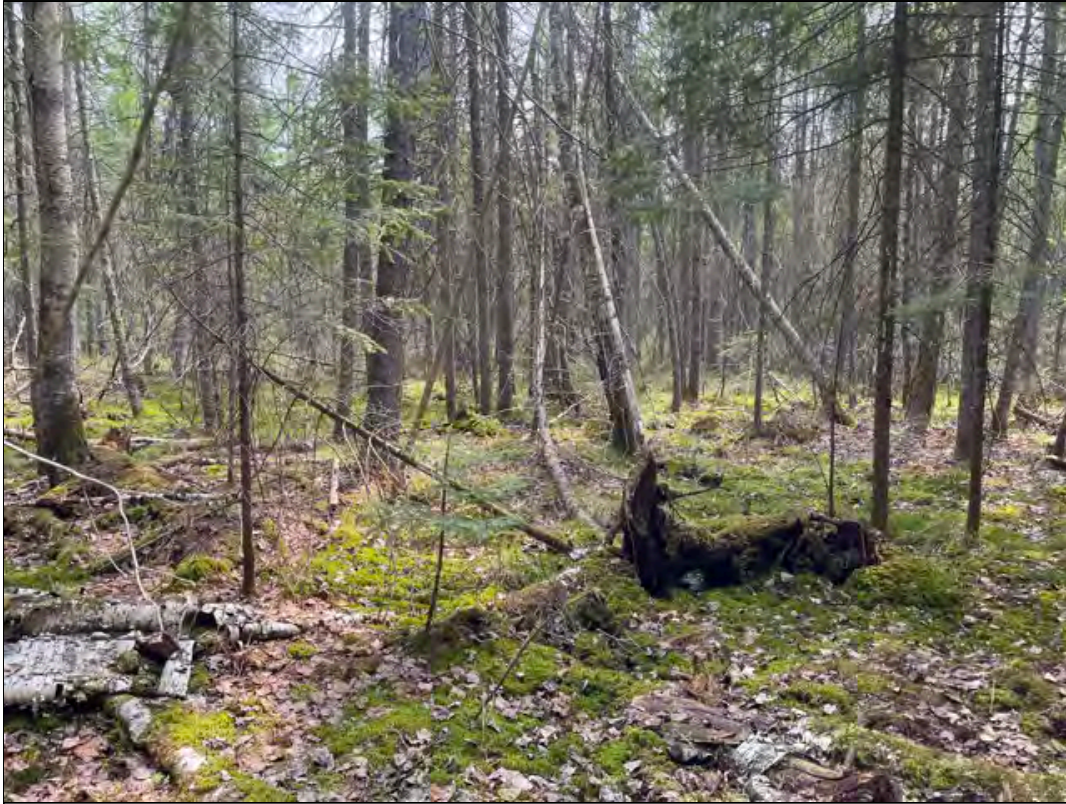
WET 2-2

Plot Wet 2-2: The plant community met wetland vegetation criteria with the Dominance Test (100.0%) and the Prevalence Index (1.723) being met. The dominant vegetation at the sample plot included black spruce, balsam fir, sphagnum moss and two-seeded bog sedge. Saturation was observed at the soil surface and high water table at -2 inches below the soil surface. Primary wetland hydrology indicators A2, A3, B9 and secondary indicators D2 and D5 were present. Soils were considered naturally problematic but met NRCS hydric soil indicator A10 (2 cm Muck) was present.

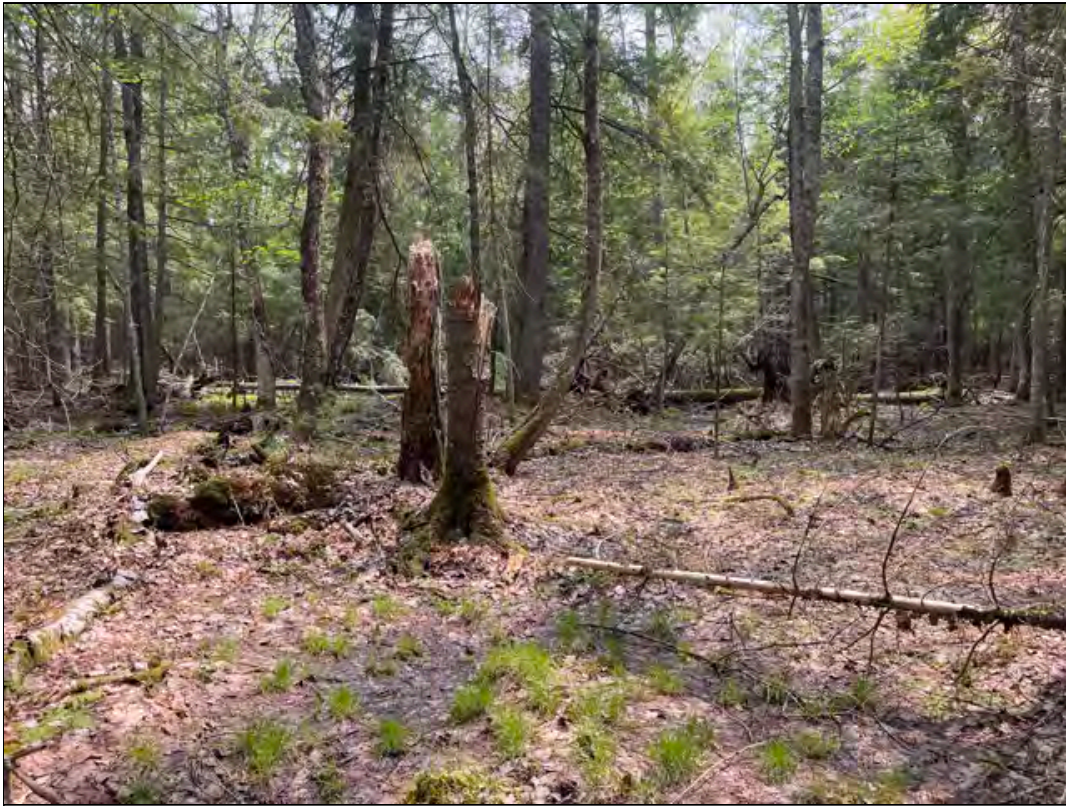
WET 2-3

Plot Wet 2-3: The plant community met wetland vegetation criteria with the Dominance Test (83.3%) and the Prevalence Index (2.719) being met. The dominant vegetation at the sample plot included red maple, balsam fir, eastern hemlock, spinulose wood fern, three-leaved goldthread and brome-like sedge. Saturation was observed at the soil surface and high water table at -5 inches below the soil surface. Primary wetland hydrology indicators A2, A3, B9 and secondary indicators D2 and D5 were present. NRCS hydric soil indicators A11 (Depleted Below Dark Surface) and F3 (Depleted Matrix) were present.

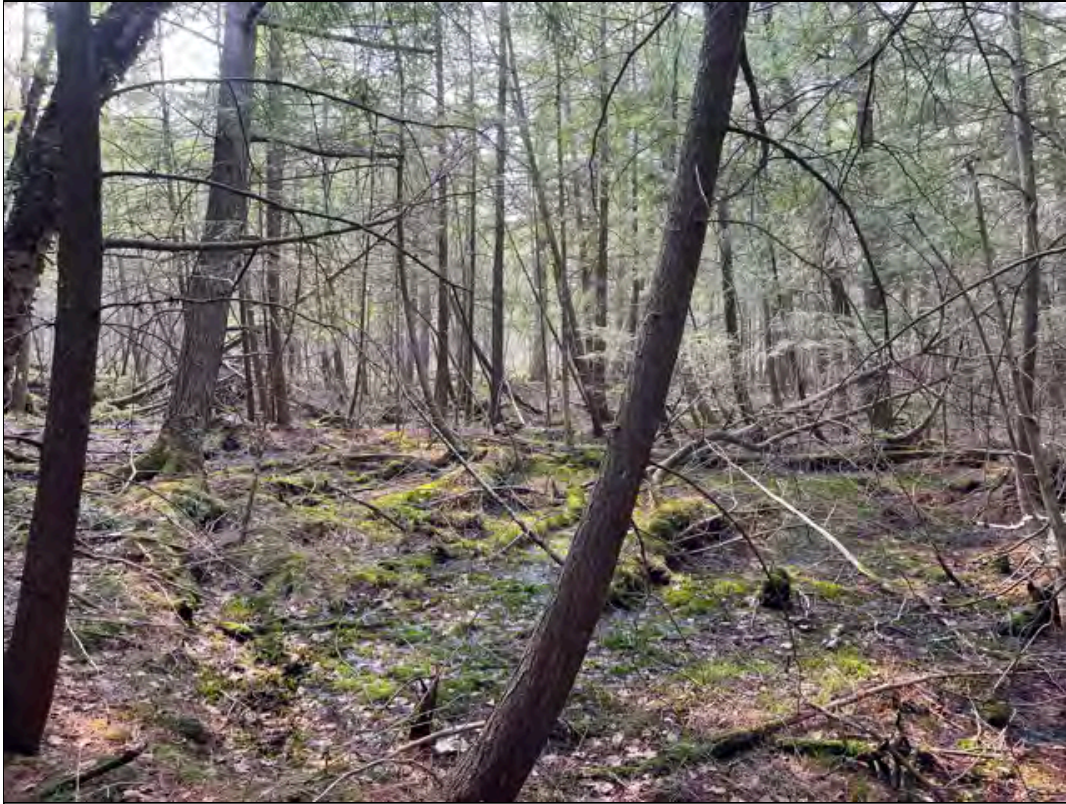
WET 2-4

Plot Wet 2-4: The plant community met wetland vegetation criteria with the Dominance Test (83.3%) and the Prevalence Index (2.719) being met. The dominant vegetation at the sample plot included red maple, balsam fir, eastern hemlock, spinulose wood fern, three-leaved goldthread and brome-like sedge. Saturation was observed at the soil surface and high water table at -5 inches below the soil surface. Primary wetland hydrology indicators A2, A3, B9 and secondary indicators D2 and D5 were present. NRCS hydric soil indicators A11 (Depleted Below Dark Surface) and F3 (Depleted Matrix) were present.

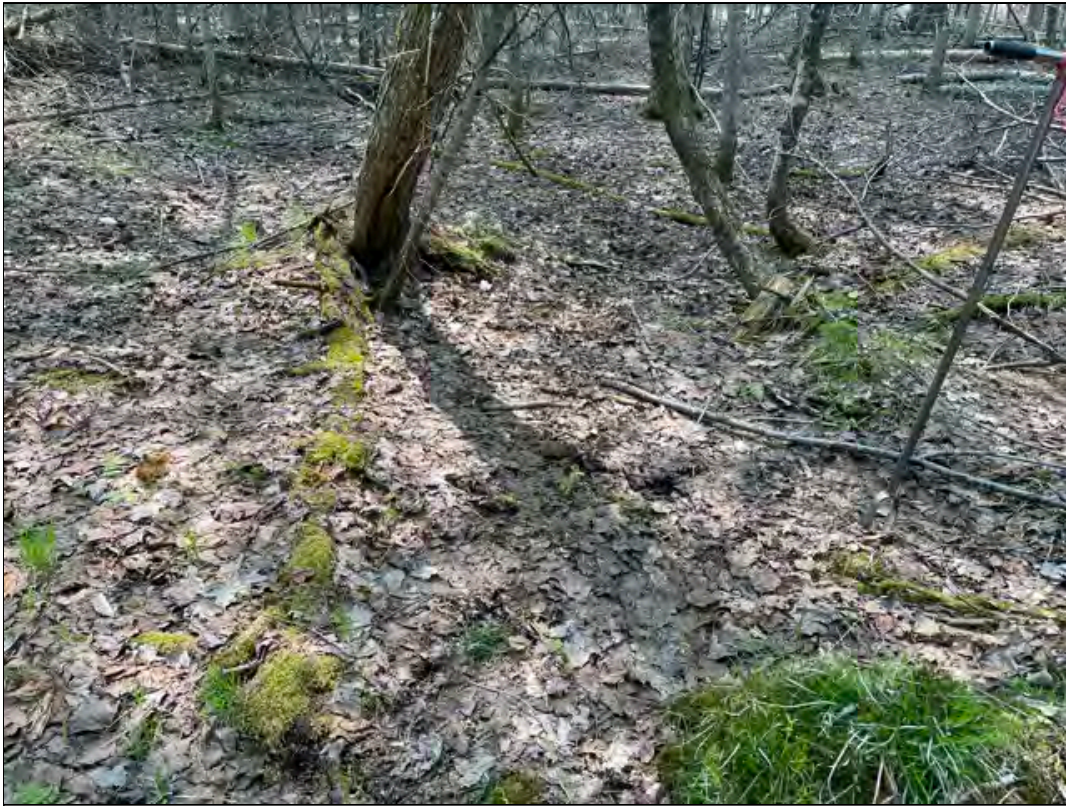
WET 3-1

Plot Wet 3-1: The plant community met wetland vegetation criteria with the Dominance Test (100.0%) and the Prevalence Index (2.788) being met. The dominant vegetation at the sample plot included red maple, yellow birch and brome-like sedge. Saturation was observed at the soil surface and high water table at -6 inches below the soil surface. Primary wetland hydrology indicators A2, A3, B9 and secondary indicators D2 and D5 were present. NRCS hydric soil indicators A11 (Depleted Below Dark Surface) and S5 (Sandy Redox) were present.

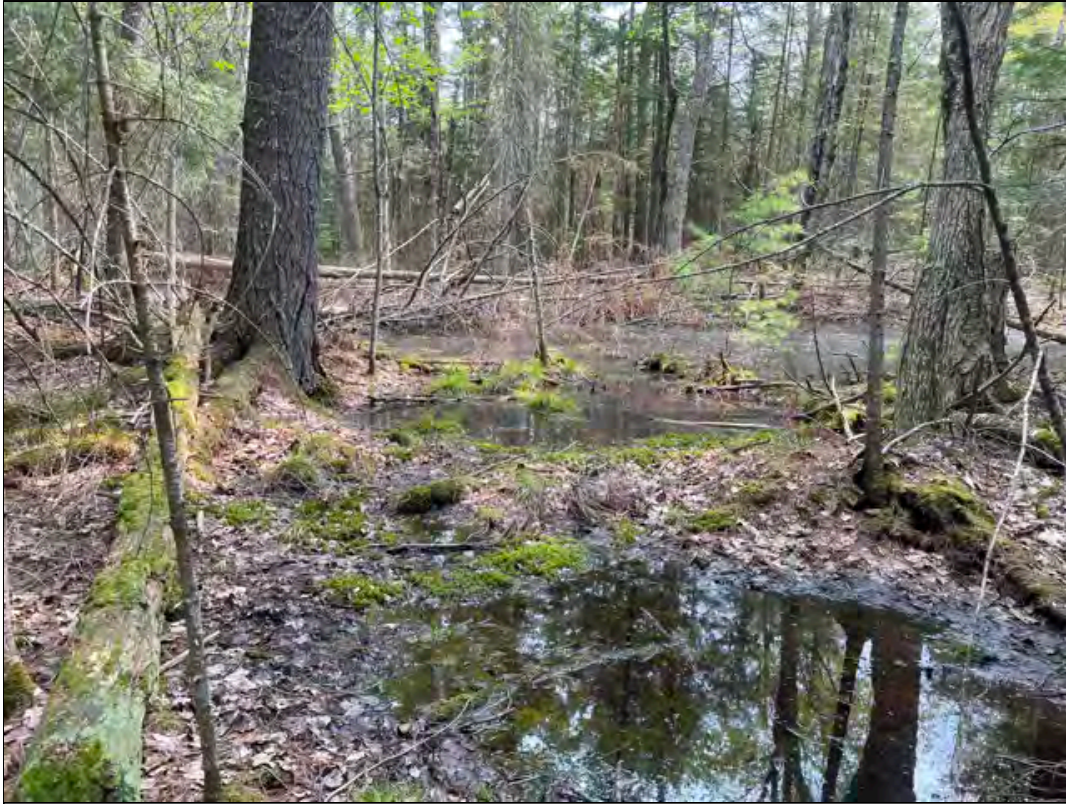
WET 4-1

Plot Wet 4-1: The plant community met wetland vegetation criteria with the Dominance Test (80.0%) and the Prevalence Index (2.517) being met. The dominant vegetation at the sample plot included yellow birch, eastern white pine, balsam fir, sphagnum moss and two-seeded bog sedge. Surface water was observed at +2 inches above the soil surface. Primary wetland hydrology indicators A1, A2, A3, B9 and secondary indicators D2 and D5 were present. NRCS hydric soil indicators A11 and F3 (Depleted Matrix) were present.

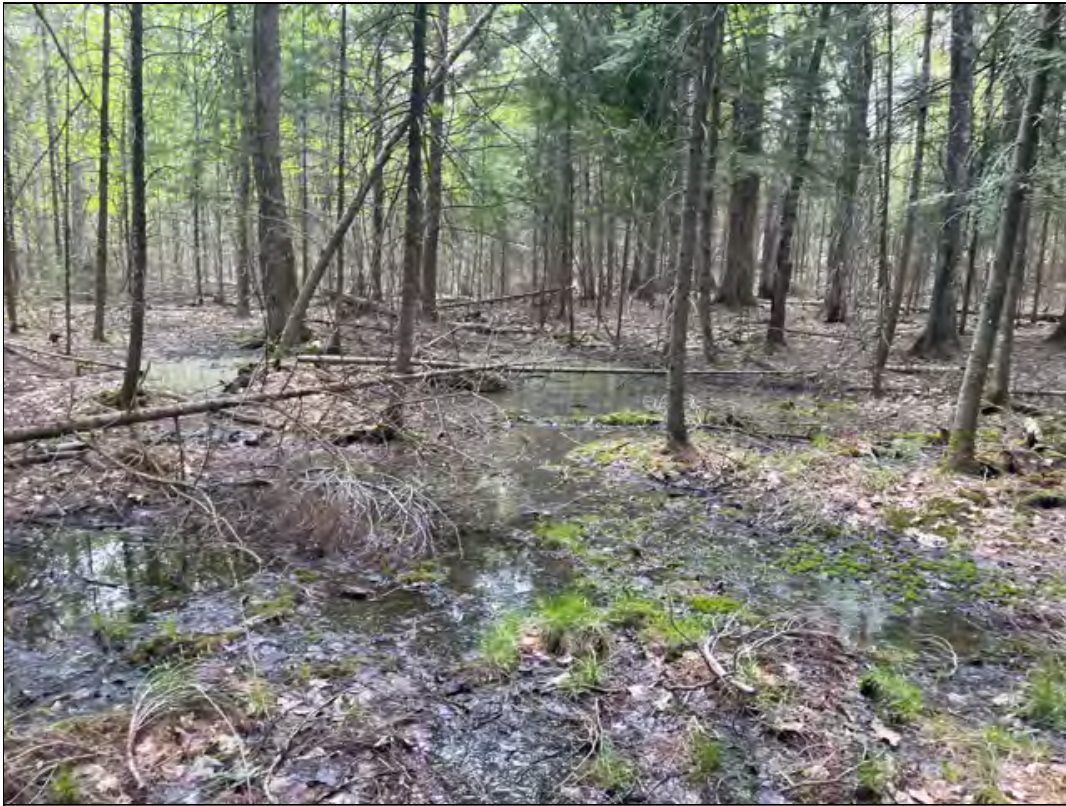
WET 5-1

Plot Wet 5-1: The plant community met wetland vegetation criteria with the Dominance Test (75.0%) and the Prevalence Index (2.278) being met. The dominant vegetation at the sample plot included balsam fir, eastern hemlock, sphagnum moss and two-seeded bog sedge. Surface water was observed at +2 inches above the soil surface. Primary wetland hydrology indicators A1, A2, A3, B9 and secondary indicators D2 and D5 were present. NRCS hydric soil indicators A11 and F3 (Depleted Matrix) were present.

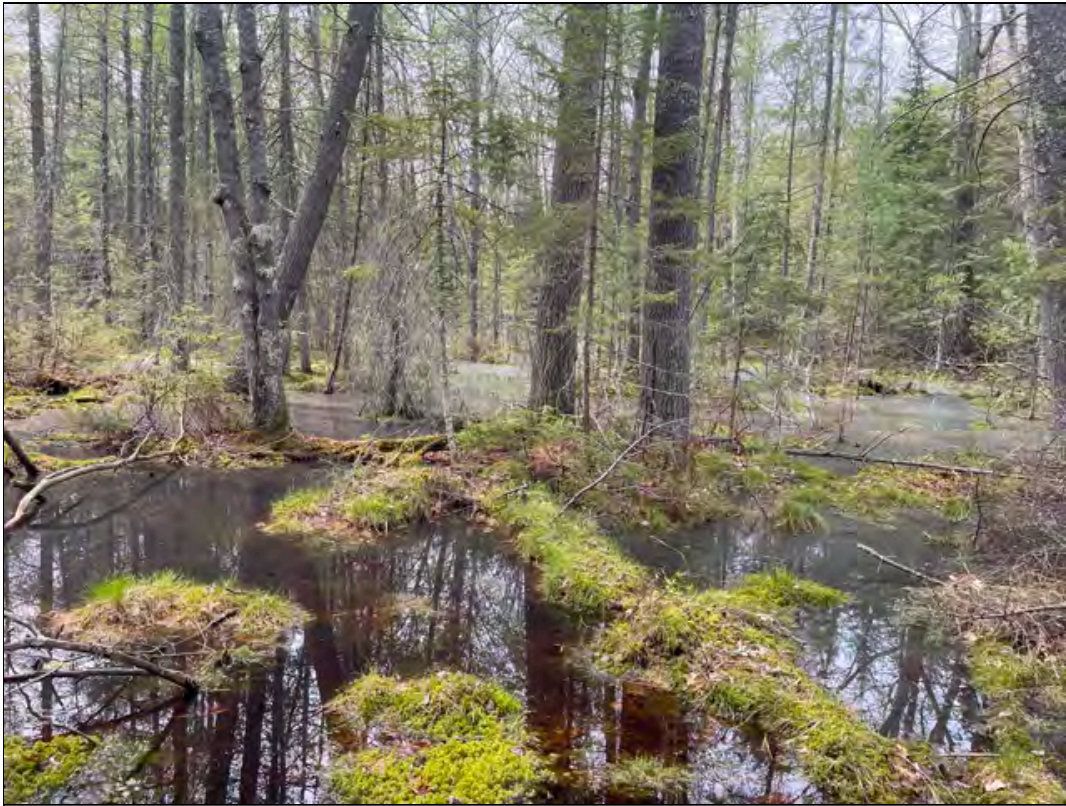
WET 6-1

Plot Wet 6-1: The plant community met wetland vegetation criteria with the Dominance Test (83.3%) and the Prevalence Index (2.269) being met. The dominant vegetation at the sample plot included eastern white pine, red maple, black spruce, balsam fir, sphagnum moss and two-seeded bog sedge. Surface water was observed at +6 inches above the soil surface. Primary wetland hydrology indicators A1, A2, A3, B7 (Inundation Visible on Aerial Imagery), B9 and secondary indicators D2 and D5 were present. NRCS hydric soil indicators A11 and F3 (Depleted Matrix) were present.

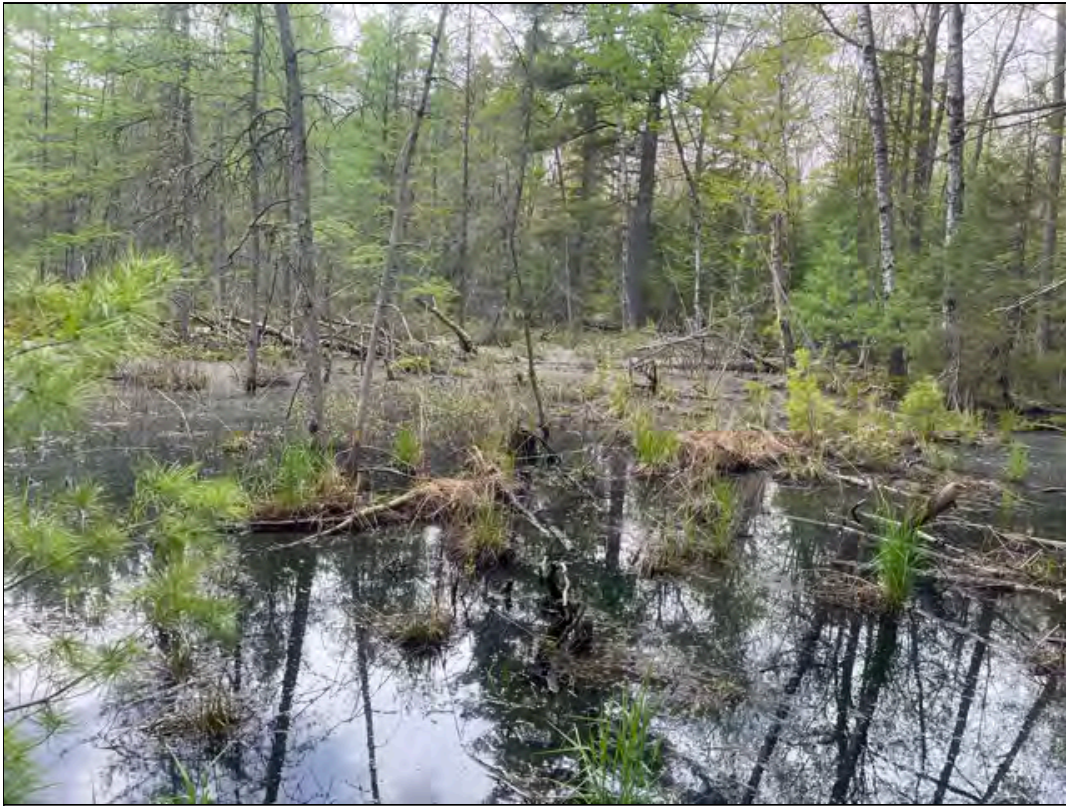
WET 7-1

Plot Wet 7-1: The plant community met wetland vegetation criteria with the Dominance Test (100.0%) and the Prevalence Index (1.328) being met. The dominant vegetation at the sample plot included tamarack, wool-grass, leatherleaf and Canada bluejoint. Surface water was observed at +8 inches above the soil surface. Primary wetland hydrology indicators A1, A2, A3, B9 and secondary indicators D2 and D5 were present. NRCS hydric soil indicator A1 was present.

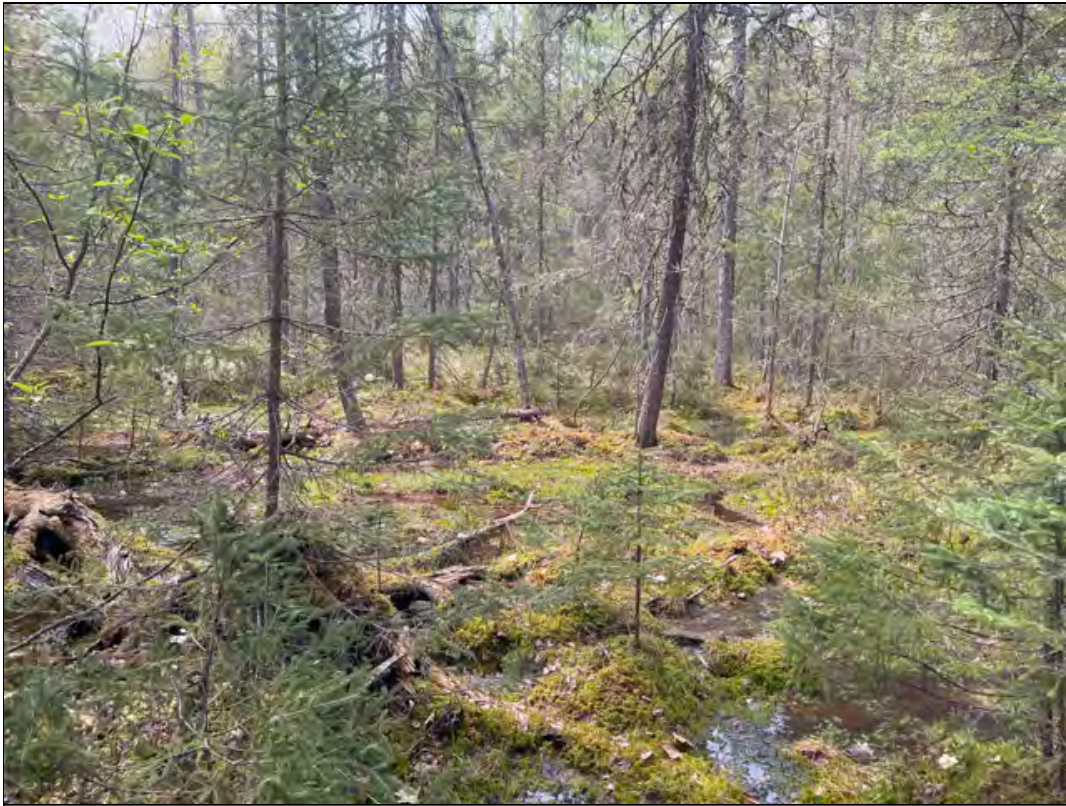
WET 8-1

Plot Wet 8-1: The plant community met wetland vegetation criteria with the Dominance Test (100.0%) and the Prevalence Index (1.487) being met. The dominant vegetation at the sample plot included tamarack, black spruce, red maple, speckled alder and sphagnum moss. Surface water was observed at +5 inches above the soil surface. Primary wetland hydrology indicators A1, A2, A3, B9 and secondary indicators D2 and D5 were present. NRCS hydric soil indicators A2 (Histic Epipedon) and A11 were present.

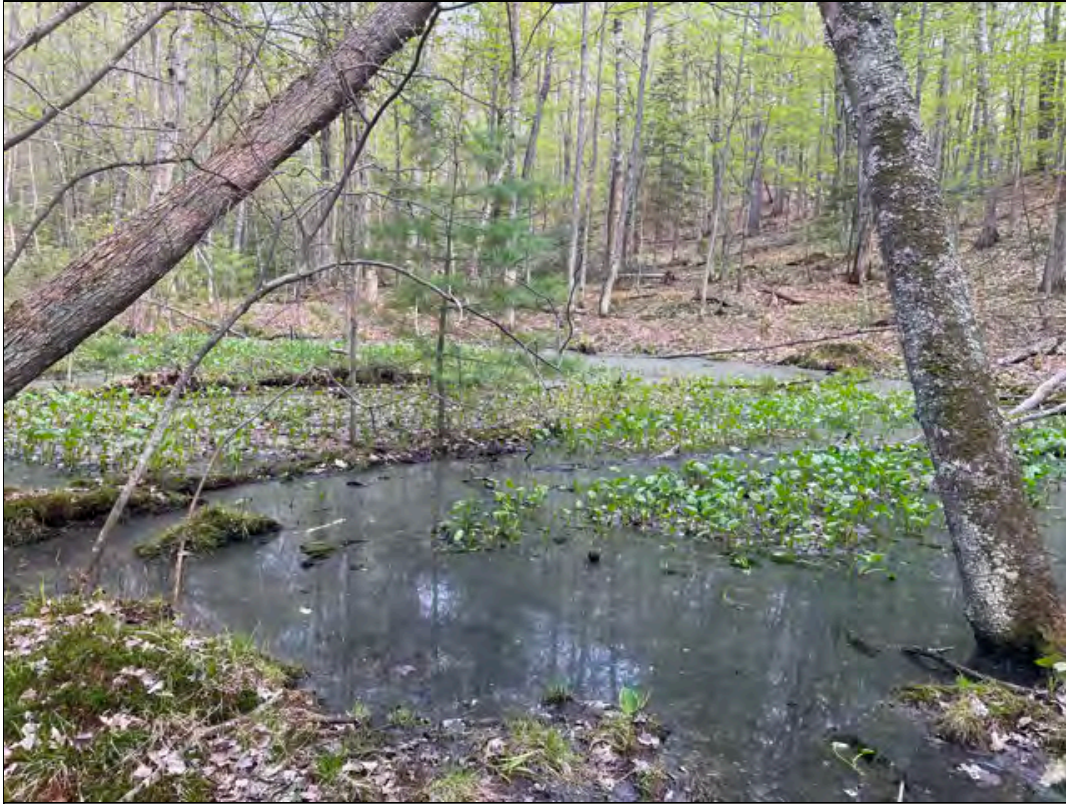
WET 9-1

Plot Wet 9-1: The plant community met wetland vegetation criteria with the Dominance Test (75.0%) and the Prevalence Index (2.000) being met. The dominant vegetation at the sample plot included yellow birch, eastern white pine, red maple and wild calla. Surface water was observed at +9 inches above the soil surface. Primary wetland hydrology indicators A1, A2, A3, B9 and secondary indicator D2 were present. NRCS hydric soil indicator S1 (Sandy Muck Mineral) was present.

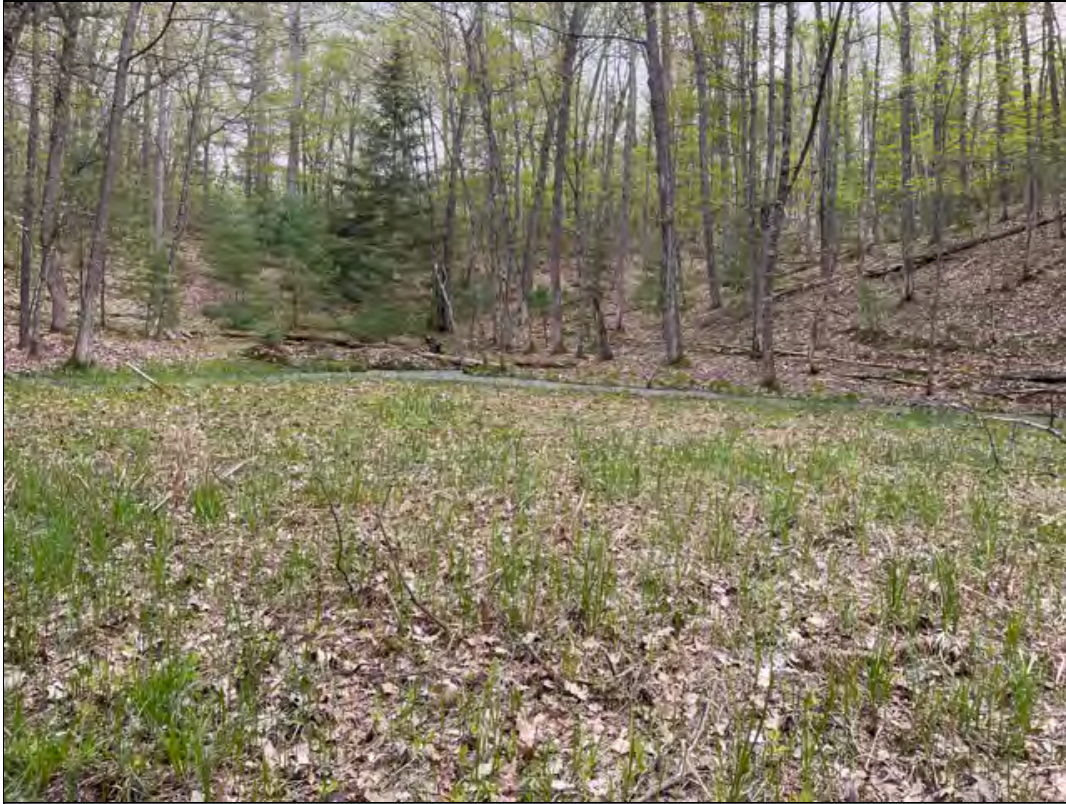
WET 10-1

Plot Wet 10-1: The plant community met wetland vegetation criteria with the Rapid Test for Hydrophytic Vegetation, the Dominance Test (100.0%) and the Prevalence Index (1.263) being met. The dominant vegetation at the sample plot included Canada bluejoint and sensitive fern. Surface water was observed at +7 inches above the soil surface. Primary wetland hydrology indicators A1, A2, A3 and secondary indicators D2 and D5 were present. NRCS hydric soil indicator S1 was present.

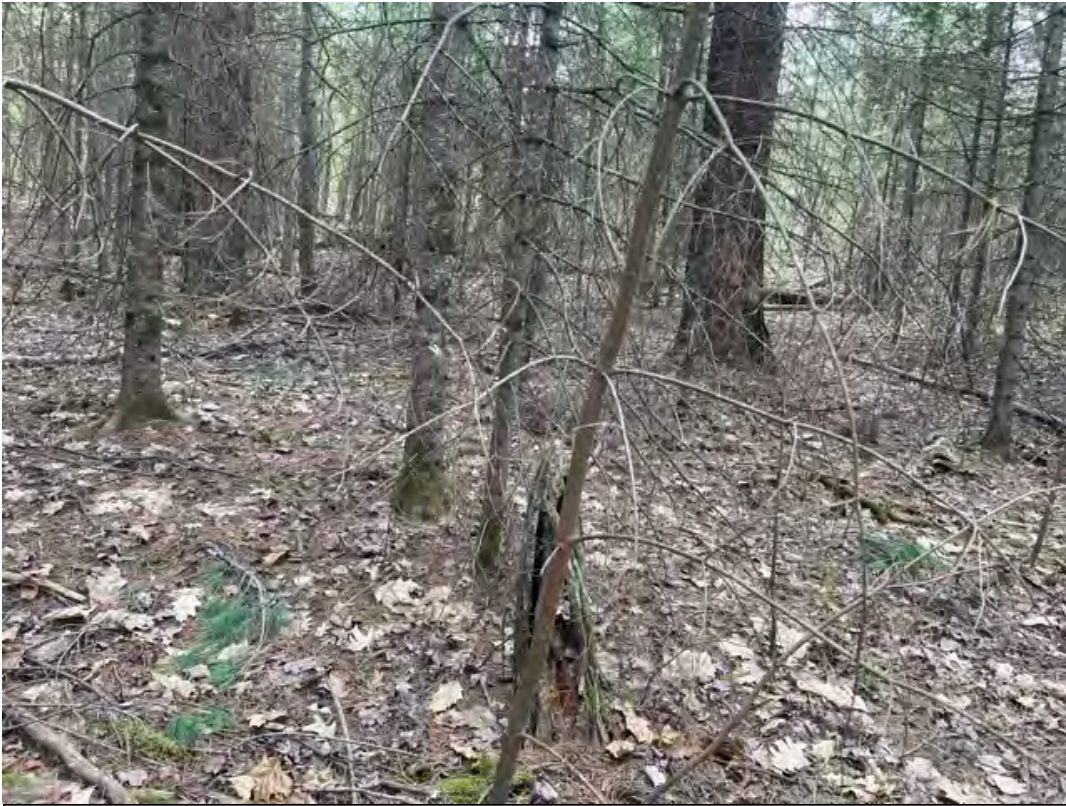
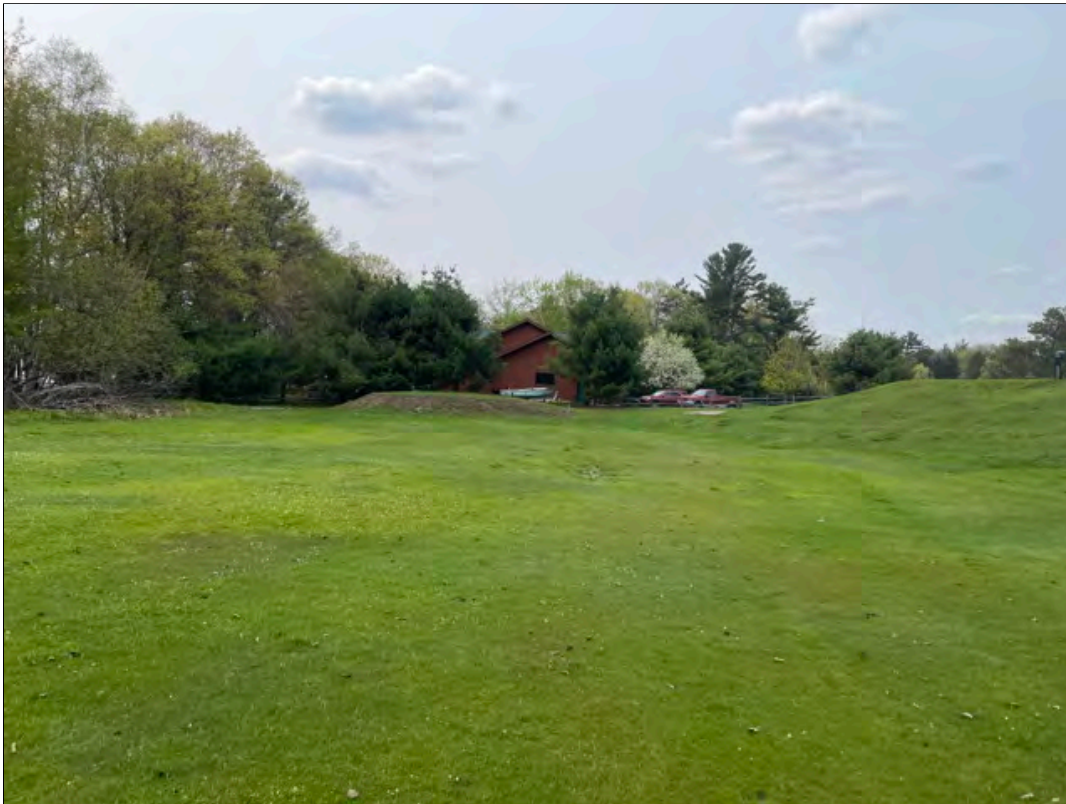
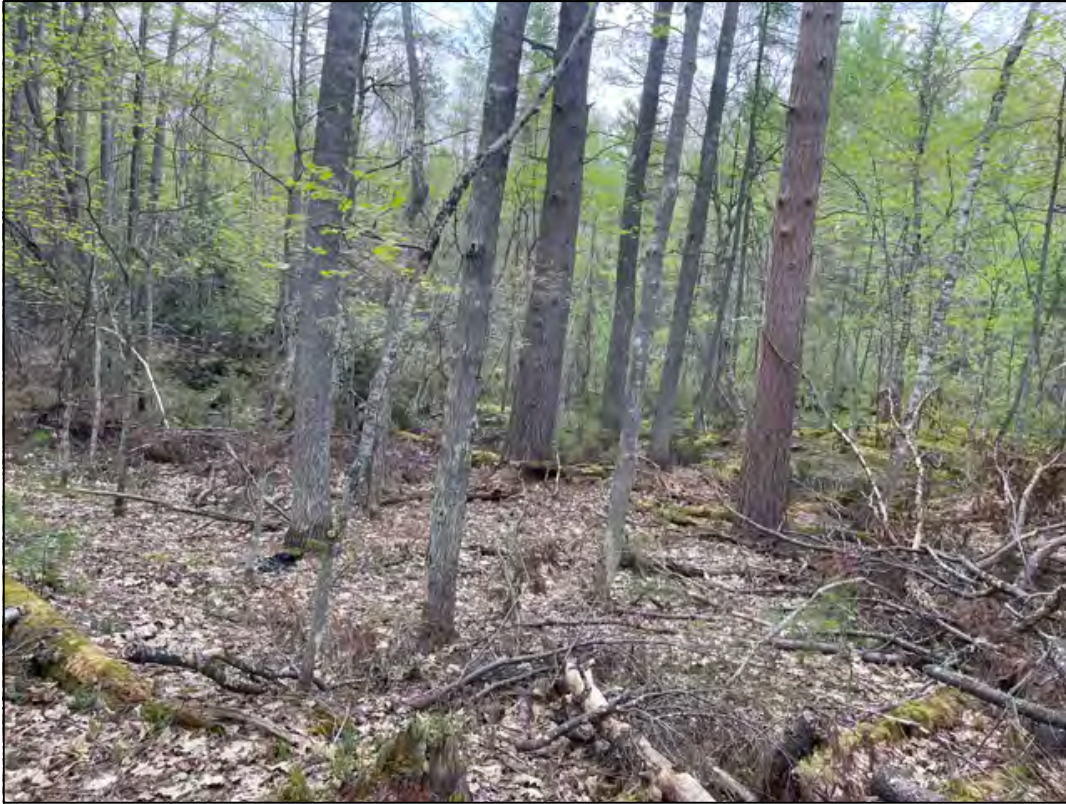
Sample plots SP1 through SP3 were taken to document upland conditions in a portion of the Study Area mapped as having wetland indicator soils. All sample plots were dominated by non-hydrophytic vegetation, soils were not hydric and no hydrology indicators were observed. The on-site visits did not find any indications of wetlands in these portions of the Study Area.

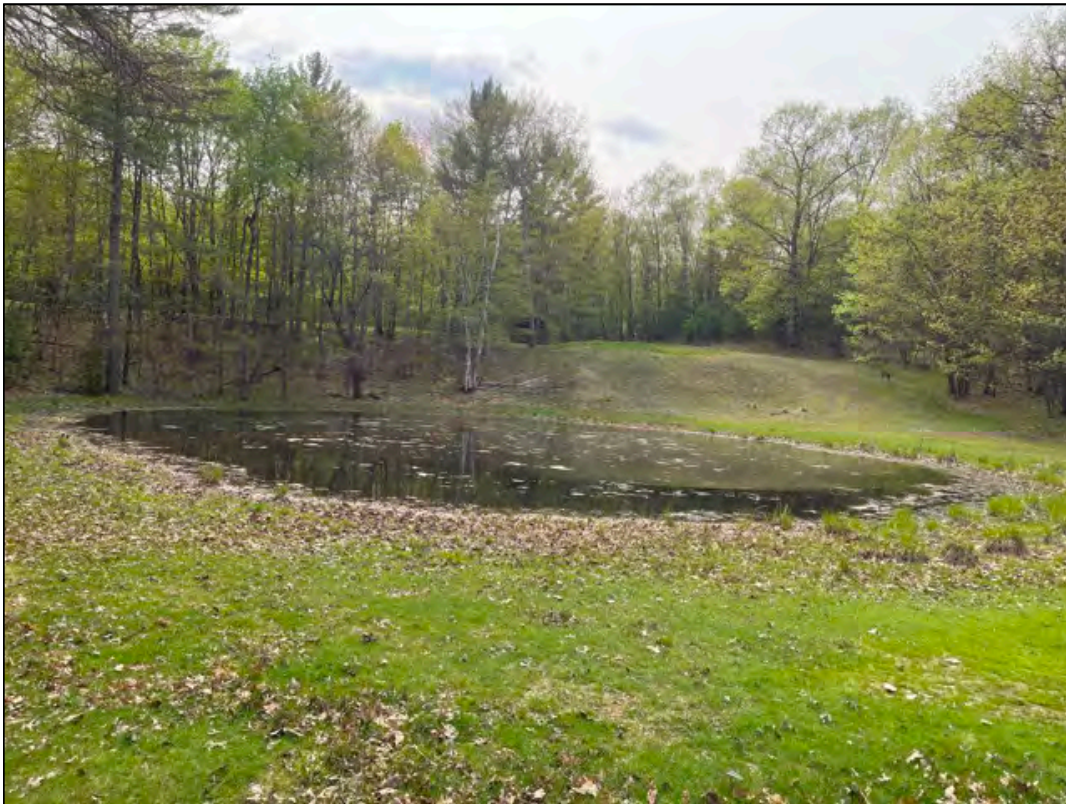
ARTIFICIALLY CONSTRUCTED POND
